## SEISMIC REHABILITATION OF TRADITIONAL UN-REINFORCED MASONRY BUILDINGS IN IRAN

**Keywords:** Seismic rehabilitation, ASCE 41-06 standard, Un-reinforced masonry building, Steel I-beam jack arch slab, Iran.

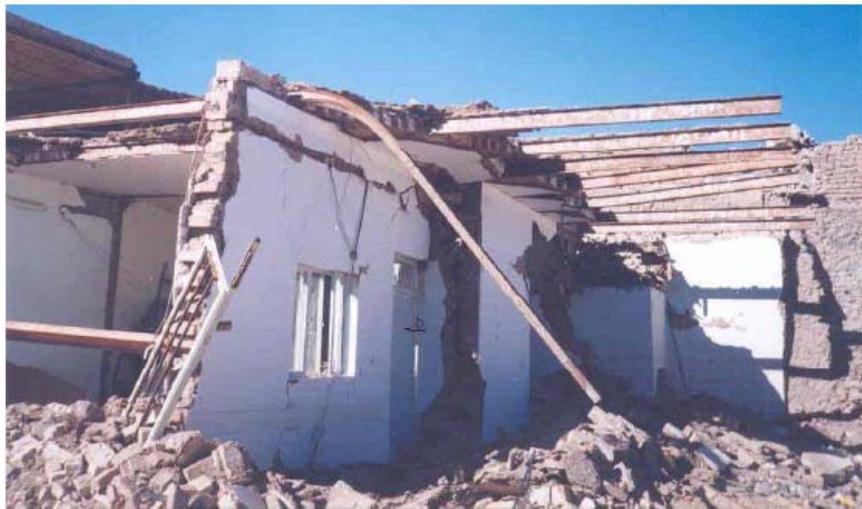
Figure 2. Damage to a traditional jack arch slab during Bam earthquake, 2003 [4].

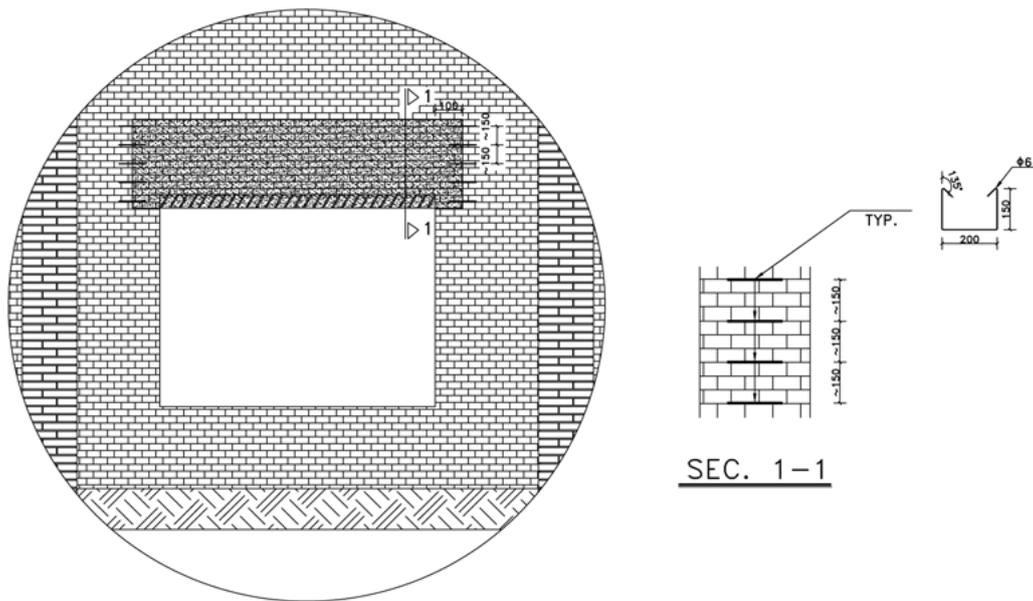
Figure 3. Decreasing of the opening dimensions.

The openings height or width in the masonry walls has been changed in order to reduce the opening dimensions as well as increasing the coupling beams dimensions. The new part of the masonry wall, as seen in Figure 3, should be connected to the existing part of the masonry wall by enough number of U shape rebars to be able to transfer the shear forces.

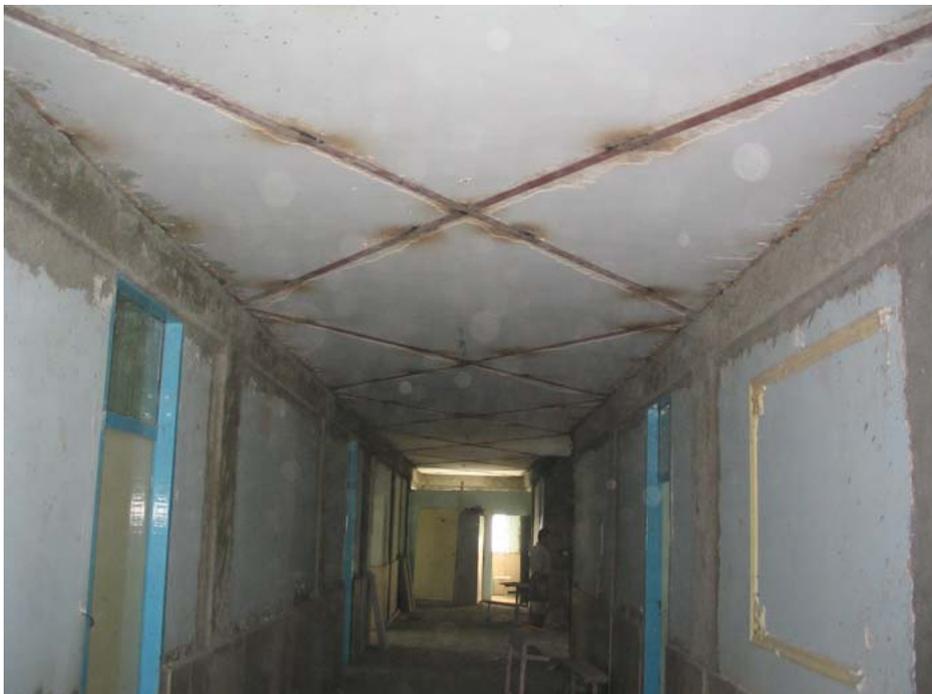
Figure 4. Adding  $50 \times 5\text{mm}$  steel plates in order to integrate the traditional jack arch slab joists.

The traditional jack arch floor slab, as described in Section 3, can not act as an integrate slab. Hence,  $50 \times 5\text{mm}$  flat bar was welded to the bottom flange of all steel I beams of the floor as shown in Figure 4. The added bar was welded, at the end, to the steel angle which is in the wall and floor intersection. The last steel I beam joist, which usually has the brick floor in only one side, should be connected to the adjacent I beam steel joist by steel flat bars at each 2 m.

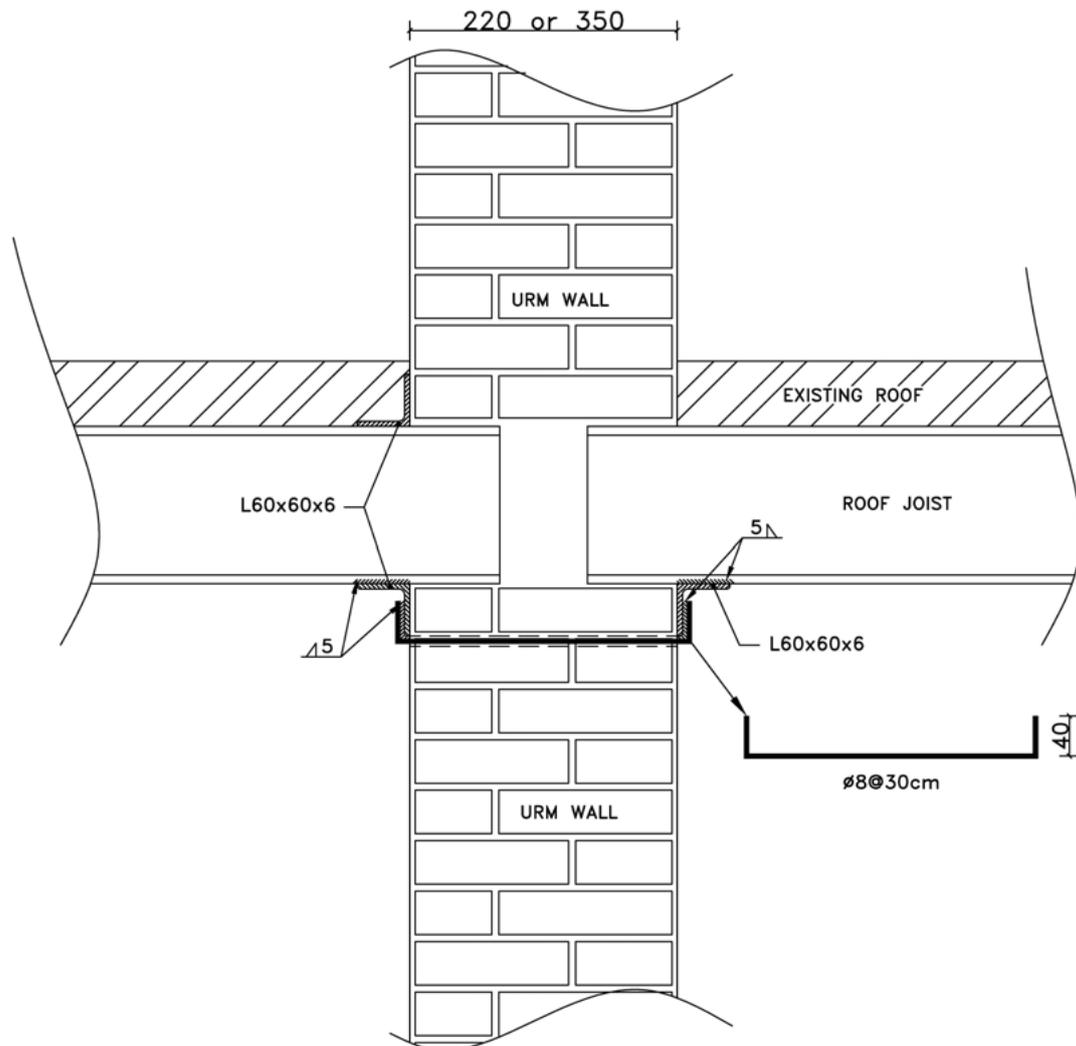
Figure 5. Adding an  $60 \times 60 \times 6 \text{ mm}$  angle to connect the wall to the floor where the floor slab joists are perpendicular to the wall.

The floor to wall connection, as described in Section 3, is usually without enough strength. That is, a steel angle  $60 \times 60 \times 6 \text{ mm}$  was added to all intersections between floor and walls. The function of the new angle can be summarized as (1) to connect the floor to the wall; (2) acts as a horizontal tie beam; (3) prevents relative movement of the steel joists in earthquake movements and (4) increases the steel joist support length. The details of the added angel are shown in Figure 5 and Figure 6, respectively, in the case of the floor slab joists are perpendicular or parallel to the wall.

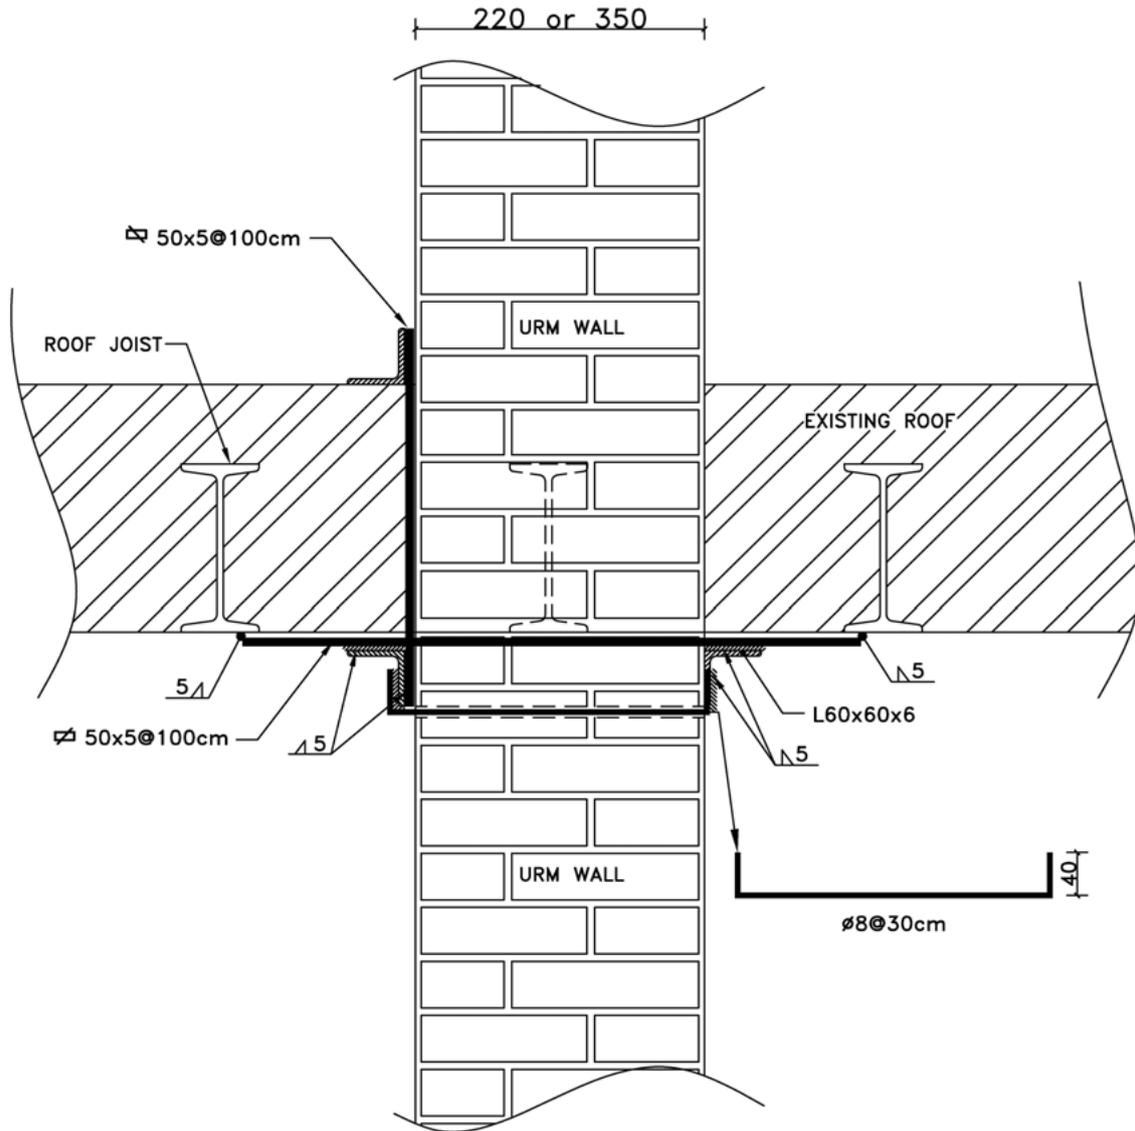
Figure 6. Adding an  $60 \times 60 \times 6 \text{mm}$  angle to connect the wall to the floor where the floor slab joists are parallel to the wall.

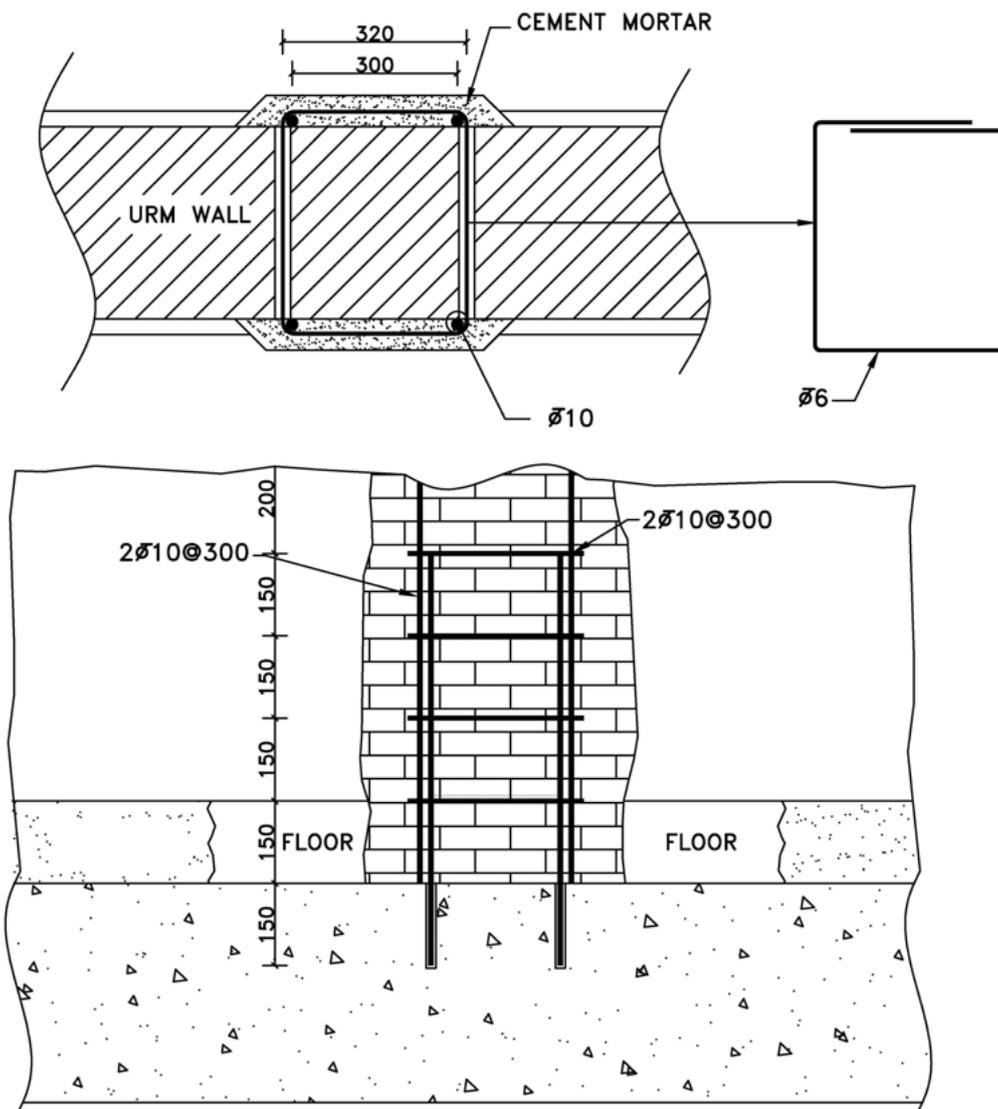
Figure 7. A typical view of the ties enhancement.

There is not any complete 3D tie system in the majority of the URM buildings, as discussed in Section 3. For construction of the 3D tie system, where necessary, a new vertical tie should be executed. Vertical rebars should be implanted in horizontal ties in the top and bottom of the walls. An alternative is the construction of masonry vertical tie beam as seen in Figure 7.

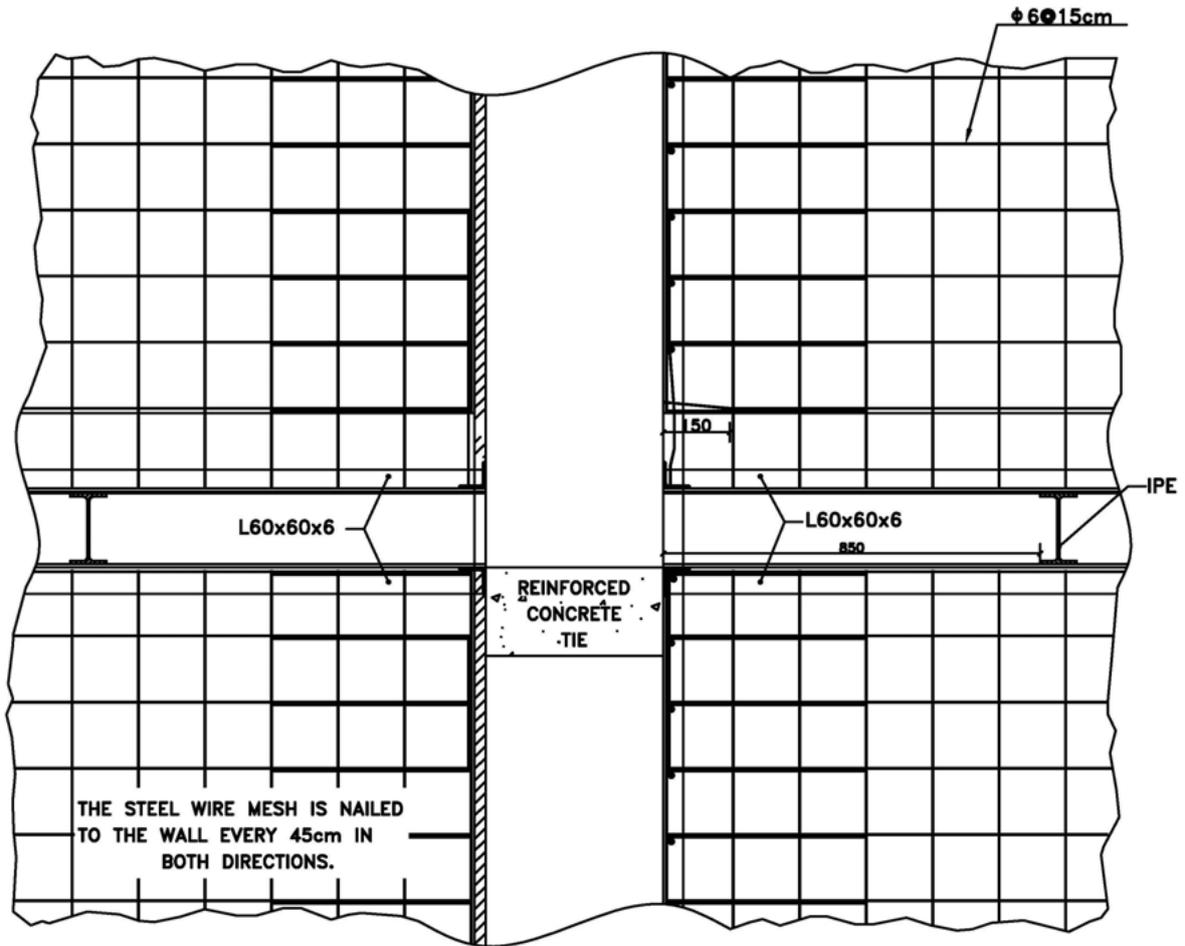
Figure 8. A typical view of the bearing wall enhancement through stories.

The masonry wall is enhanced by jacketing with the wire mesh and cement plaster where the capacity of the bearing wall is less than the induced earthquake forces. The details of this method, which is one of the URM wall enhancing methods, can be seen in Figure 8. The enhancement layer should be connected properly to the surrounded ties to be able to transfer the load through stories and deliver it to the foundation. Approximately nine bricks are pulled out from the existing masonry wall, as shown in Figure 9, to make the shear keys between the new layer and the existing masonry wall. The added steel mesh connects to the existing masonry wall by enough number of steel nails. The steel mesh is welded to the corner steel angels, as seen in Figure 10, to make a robust connection between the bearing wall and the floor slab. However the bearing wall is not always without openings. Hence, as shown in Figure 11, the bars should be placed around the openings and the  $45^\circ$  added bars should be placed around the electrical equipment boxes.

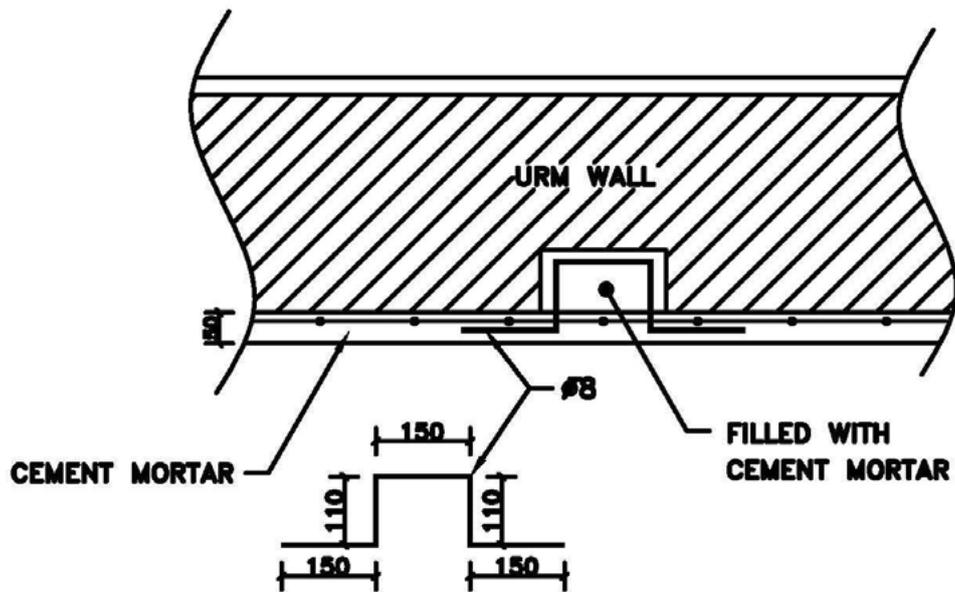
Figure 9. Increasing the strength of the URM wall.

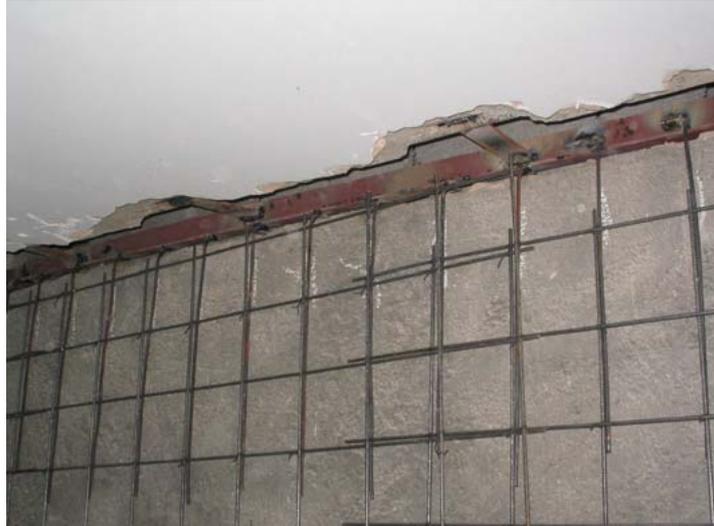
Figure 10. A typical view of the intersection between enhanced bearing walls and floor slab.

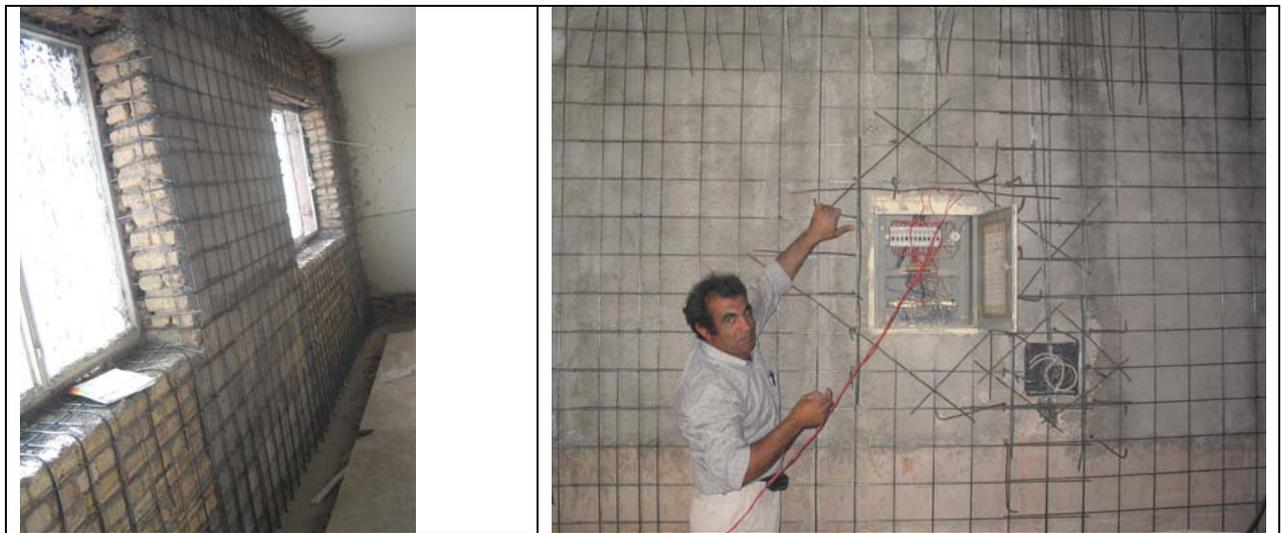
Figure 11. (left) A typical view of the enhanced bearing wall around the openings, (right) A typical view of the enhanced bearing wall around the electrical equipments box.
